TECHNICAL MEMORANDUM 226

ROCKET SLED IMPACT TESTS
OF BULK CONTAINERS FOR ETIOLOGIC
AGENT STORAGE AND SHIPPING

Edward L. Tray

APRIL 1971

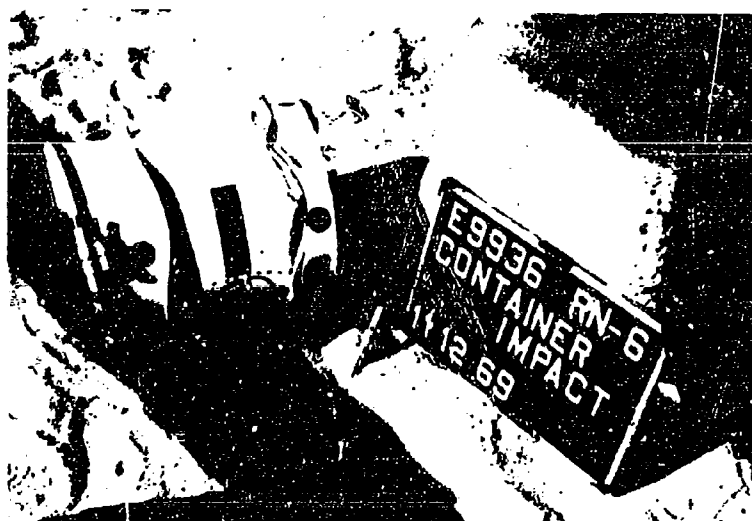
FIGURE 17. Typical Damage to the 1-gal System Bearing Impact on the Bottom.

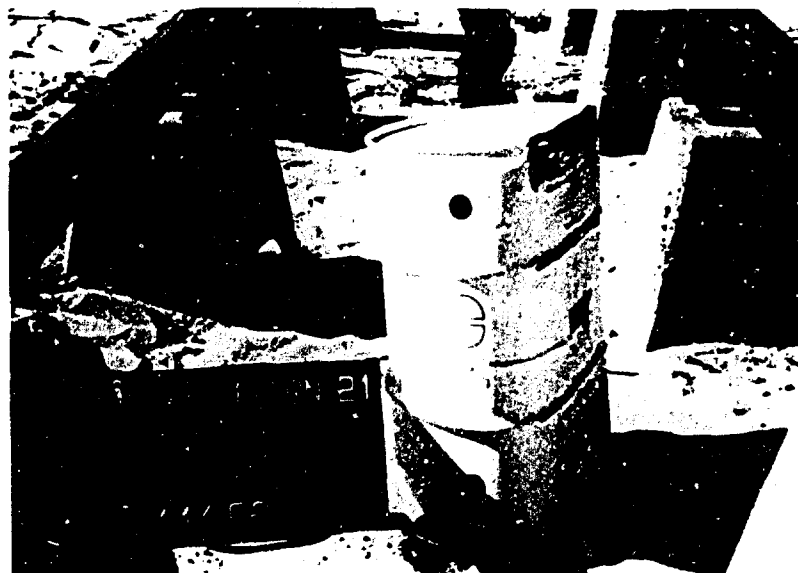
FIGURE 21. Full View of Impact Side Showing Typical Damage to the 5-gal System.
